Civil Aviation Authority
SAFETY NOTICE
Number: SN-2021/015

Issued: 8 July 2021

Engine Valve Springs
Rolls-Royce and Packard Merlin (All Marks)

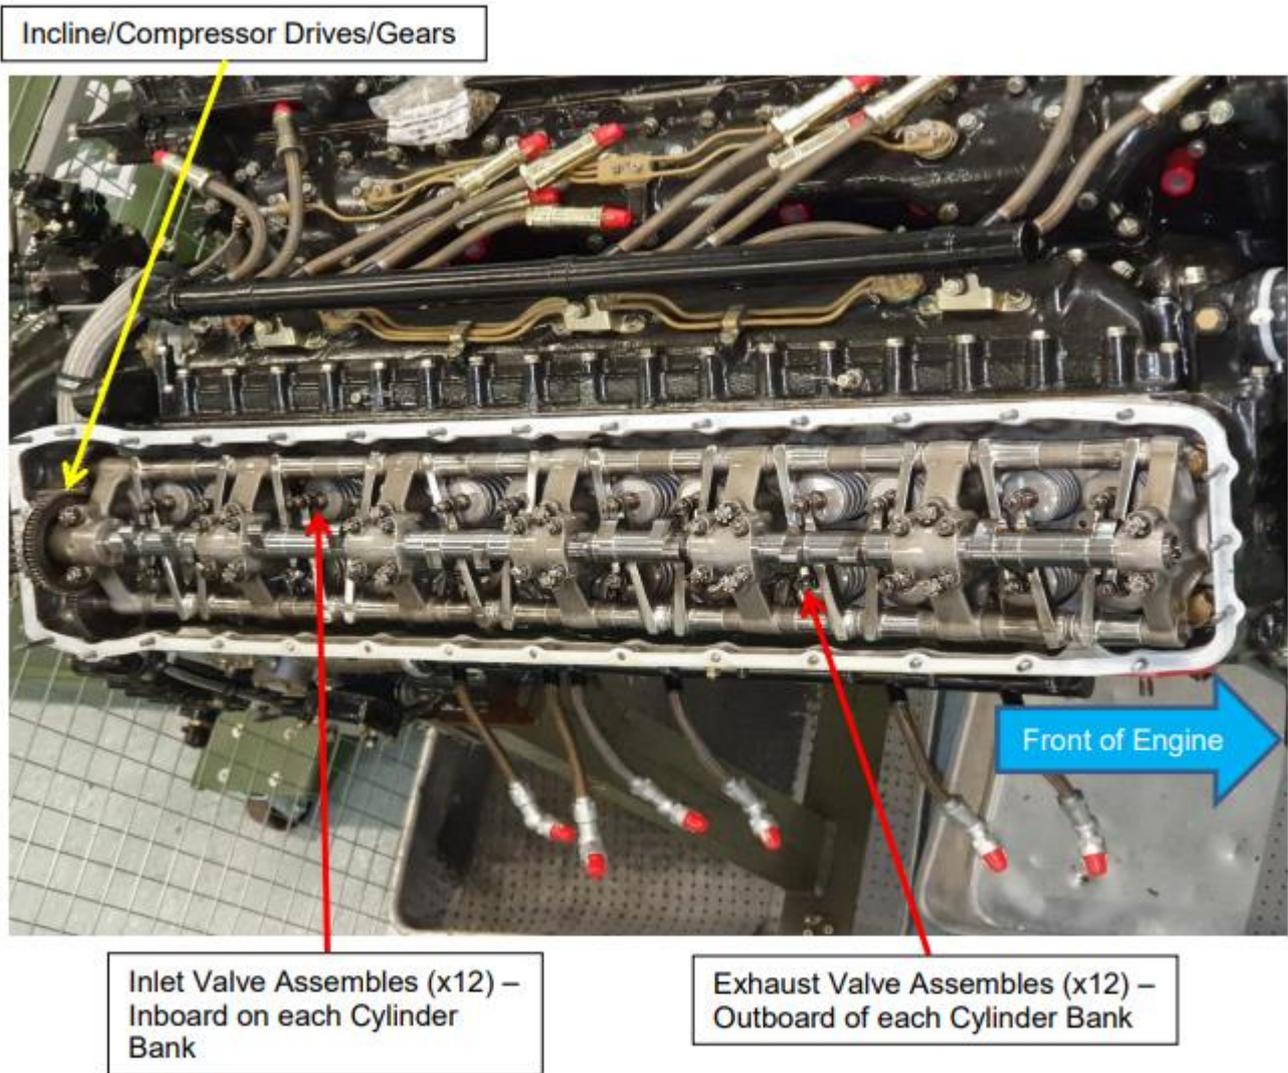
Figure 1: Merlin Engine A&B Bank Components Area of Inspection

- 2.1 For all Merlin series piston engines, operators should carry out inspection of the affected parts by way of:
- 1) Removal of engine cowlings as required to gain access to the engine cylinder banks and valve rocker covers to inspect in-situ the following items: All A and B bank inner, plus outer valve springs and spring retaining collets.

- 2) Visually inspect valve springs and collars for signs of gouging, scoring, surface pitting, corrosion or fractures to the springs and retaining collets.

- 3) Check for evidence of missing surface protection on the valve springs and retaining collars. This is evidenced by bright bare metal shiny areas due to rubbing or fatigue, and subsequent loss of surface treatment protection. Such areas should be carefully examined for the onset of corrosion or surface pitting.

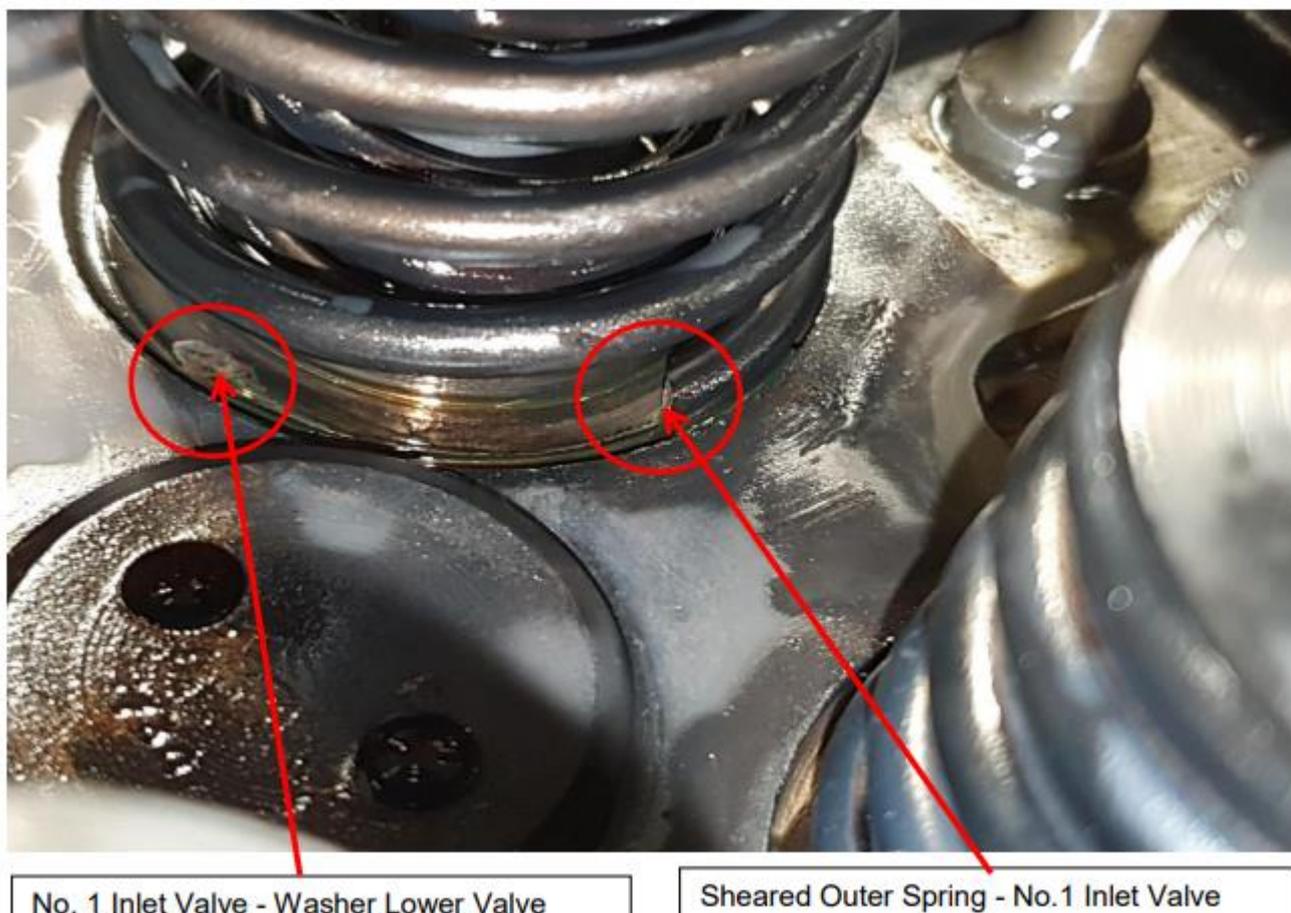
- 1.3 An examination and study of a recently found failed inlet valve spring and retaining collet determined that the likely cause was a spring and retaining collet failure due to a high cycle fatigue mechanism propagating from an area of corrosion pitting. The associated collet also subsequently failed due to a high-cycle fatigue mechanism propagating from a corrosion pit or gouge.

Figure 2: Failed Inlet Valve Outer Spring

- 4) If evidence of gouging, surface pitting or corrosion are found, it is recommended that the component and/or collet should be removed and replaced prior to further flight.
