AIRWORTHINESS BULLETIN

AWB 02-064 Issue 1 – 3 July 2020

Preventing Carbon Monoxide Poisoning in Piston Engine Aircraft

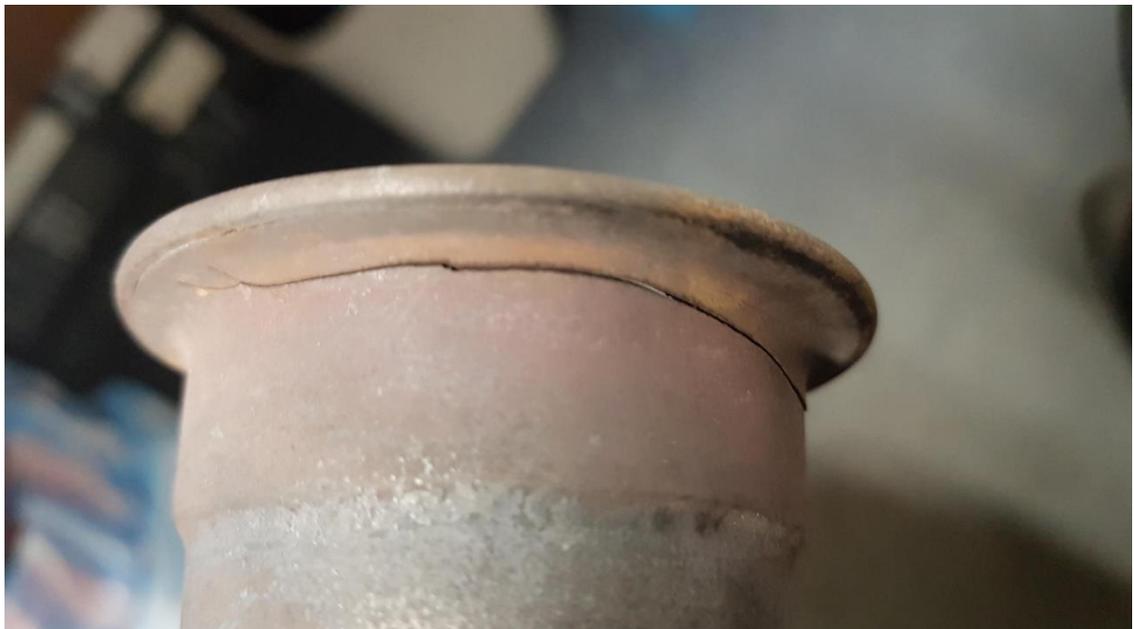
Figure 1

Lycoming TIO540 J2BD Engine exhaust muffler assembly U/S potential to leak CO into the aircraft cabin.

Firstly, the exhaust collector assemblies on piston powered aircraft are a known source of CO. Manufacturer's instructions for continued airworthiness (ICA) require regular inspection of exhaust pipe collectors and heat exchangers. Their useable life is centred on an "on condition" maintenance inspection philosophy and as such requires increased vigilance with ageing exhaust components.

The Civil Aviation Safety Authority recommends that when LAME/AMEs conduct visual inspections of exhaust collectors and heat exchange units, that a thorough inspection is conducted with the view of finding potential CO poisoning points/cracks. Whilst the internal condition and thickness of exhaust components is difficult to determine visually, if the component exhibits signs of thinning, cracking, bulging or any exhaust leakage the section should be removed and replaced with a new or serviceable/repaired item.

An ideal maintenance program would involve system replacement at engine change or at a predetermined interval gained from operating experience. To operate these items to a point of failure is not considered appropriate. Any modification or reduction in length of the tail pipe/exhaust system must be conducted with original equipment manufacturer approval or local Australian CASR Part 21 approval.

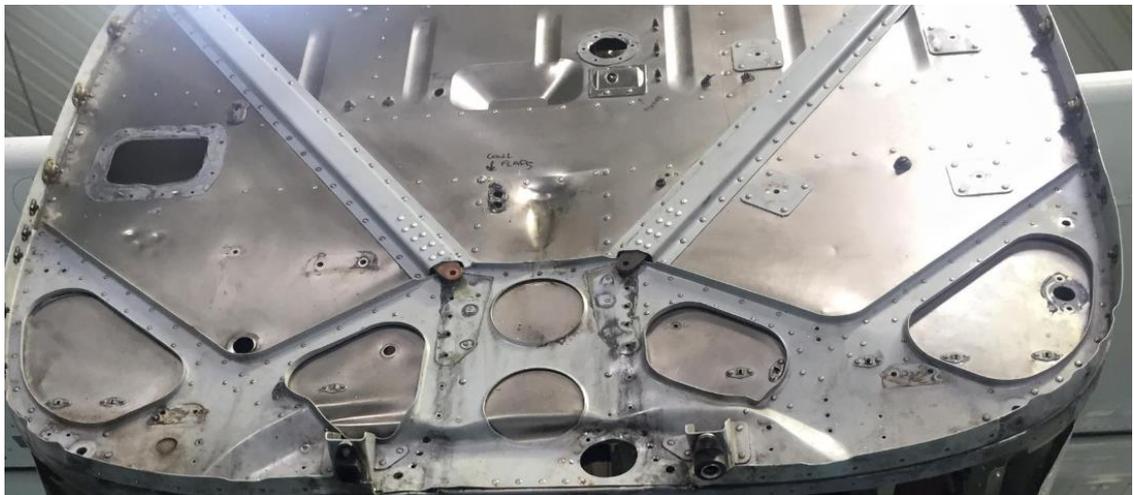
Figure 2

Secondly, the CO possibly enters the cabin either via heating ducting, open voids in the engine firewall or open doors and windows. Whilst the latter two are unavoidable, the firewall integrity, heating ducting and control valves need to be inspected to ensure correct operation and sealing. Modifications and access panels installed within firewalls for maintenance must be re sealed and secured correctly following all maintenance actions.

Engine firewall openings that may be required to be opened for maintenance and repairs must be correctly fastened and sealed prior to flight thus preventing CO from entering the cabin.

Secondly, approved modifications that include access panels and attachments to firewalls must be re-sealed following all disturbances to prevent CO entering the cabin. Heating ducts and on/off valves should function correctly, particularly in the off position to allow the pilot to stop the flow of contaminated air entering the cockpit. If an access panel on the engine firewall is opened/removed during maintenance/servicing for gaining access, ensure that the access panel seals/gaskets and hardware is reinstalled correctly to prevent the flow of gases and flammable fluids entering the cockpit and cabin.
