# Safety Advisory Notice

To Yakovlev Aircraft Factories Yak-52 owners and maintainers

Number: AO-2019-027-SAN-024

## Elevator bellcrank inspections

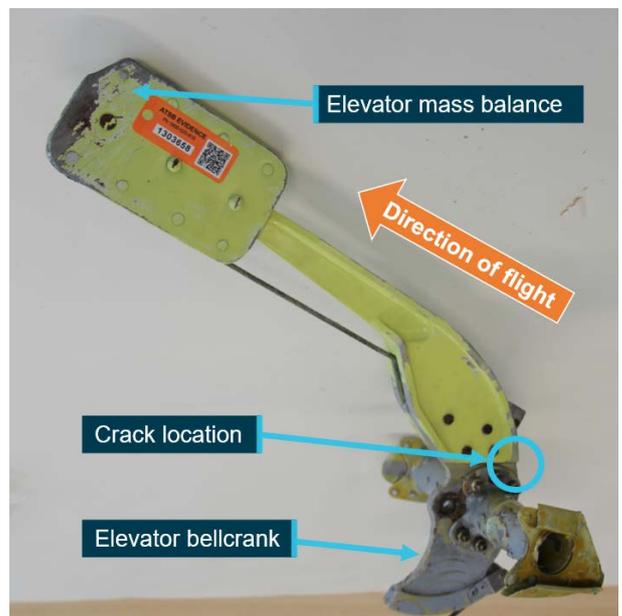
Elevator bellcrank and mass balance removed from VH-PAE

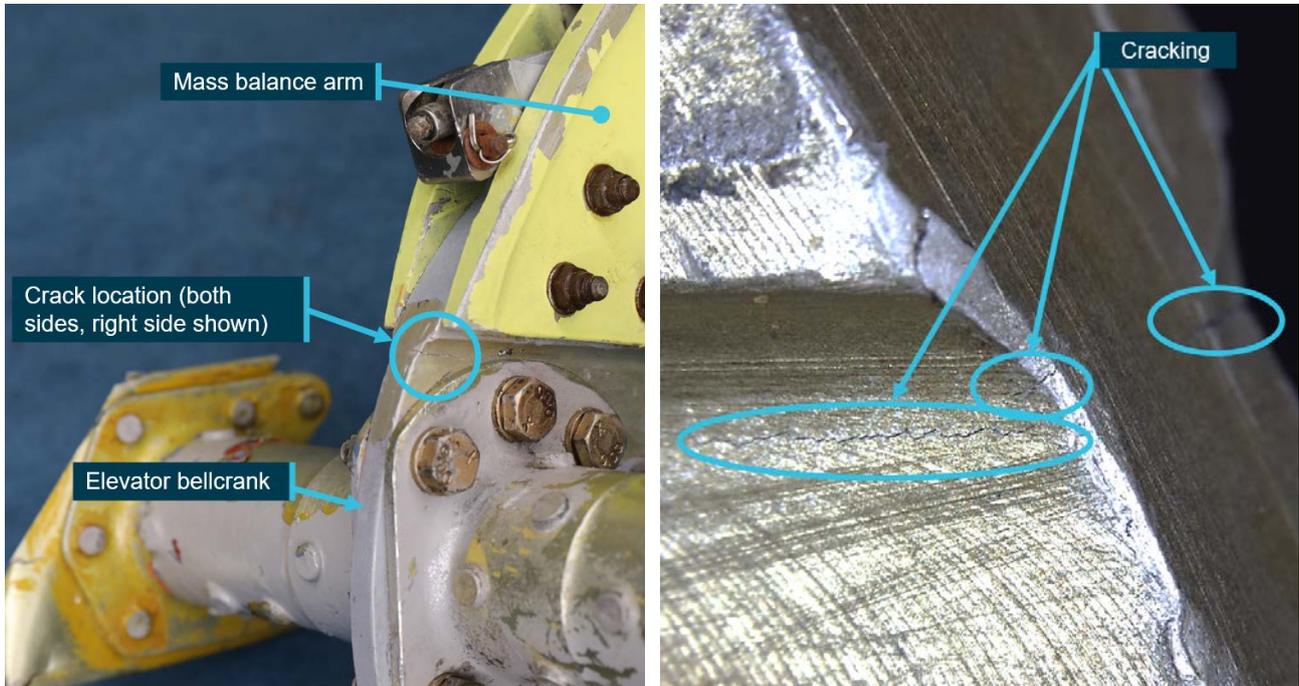
**Figure 1: Elevator bellcrank cracks observed on VH-PAE**

During the wreckage examination, the ATSB identified two small cracks at the change in section of the elevator bellcrank. The location was coincident with that identified in previously published airworthiness directives<sup>1</sup> and the manufacturer's airworthiness data. Further examination confirmed at least one was a pre-existing fatigue crack (Figure 1). Although this crack did not contribute to the accident, if not detected, cracking in this area could result in failure of the bellcrank and a subsequent loss of aircraft control.

**AO-2019-027-SAN-024:** Given the known fatigue cracking and potential failure of Yakovlev Aircraft Factories Yak-52 elevator bellcranks manufactured from aluminium alloy, the ATSB reminds maintainers and operators of the importance of dye penetrant inspections to remove defective bellcranks from service. The ATSB would also like to ensure that operators and maintainers of Yak-52 aircraft are aware that Russia, the aircraft's state of design, increased the inspection frequency for the bellcranks to  $25 \pm 5$  flying hours. Further, aluminium alloy bellcranks are no longer approved for use on Yak-52s operating in Russia.
