Airworthiness Bulletin

AWB 01-033 Issue 1 - 11 March 2021

DH82 Series Tiger Moth – Unapproved Joint H Structural Bolts

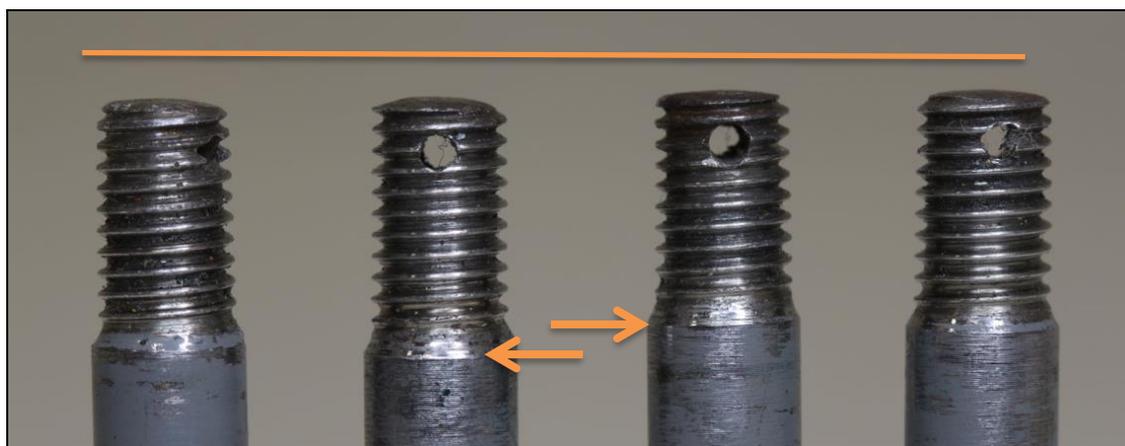
Figure 1. (Source: ATSB)

During tie rod/bar replacement and annual inspection in accordance with CASA AD/DH 82/10 Amdt 1 mandating de Havilland Support Limited (DHSL) Technical News Sheet 29 four (4) unapproved bolts, two (2) above each tie rod at each lower wing attachment fitting at Joint H, had been installed, instead of the required ‘Special to Type’ Part No.H37868 bolts.

In more than one case, the unapproved bolts have been identified as having been machined from (British) Aircraft General Spares (AGS) “G” (5/16”) diameter bolts, and that

the grip length of the bolts varied, being all significantly shorter - between approximately 1.39" to 1.42"- when compared to the DH82A DHSL specification of 1.45". (Refer Figure 1, and also see Figure 6).

Refer to the Aircraft Log Book and determine if de Havilland Support Limited (DHSL) Special Bolts Part No. H37868 have been installed in all four H Joint locations.

Confirm that the correct bolts are installed by gaining access to, and checking all H Joint upper bolt head markings (Figure 5b and 5c) to determine if the correct bolts are installed in all locations. The letter “G” (Figure 2) on the bolt head may indicate unapproved bolts have been installed. Some unapproved bolts may have no head markings (Figure 5a, b & c.).

Remove all unapproved bolts. Inspect the bolt holes and take action as required in accordance with the current issue of DHSL CT Moth TNS data, including inspecting the inside of the H Joint fitting for thread marks and for gouging in compression tube end fitting caused by unapproved oversize bolt head fouling. H Joint bolt removal and installation should be accomplished with the aircraft on trestles.

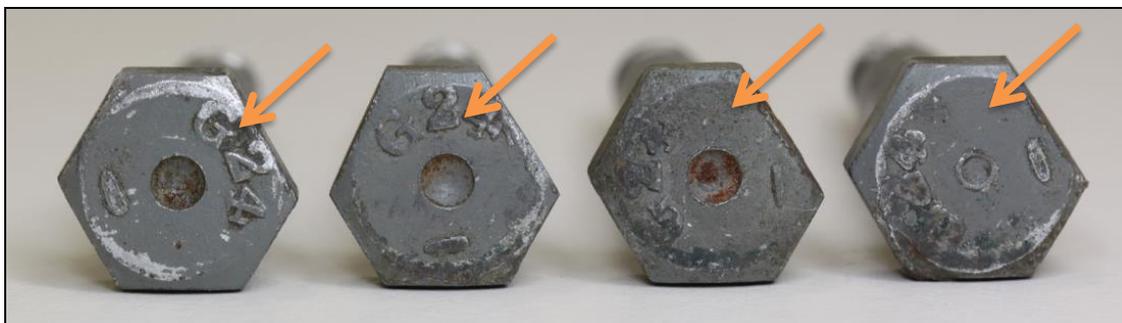
Figure 2. (Source: ATSB)

Also, one flat on the hexagonal head of each "G" bolt had been ground down to enable the larger diameter letter "G" bolt head to fit inside the flanged fitting of the main lateral compression tube. (Figure 2).

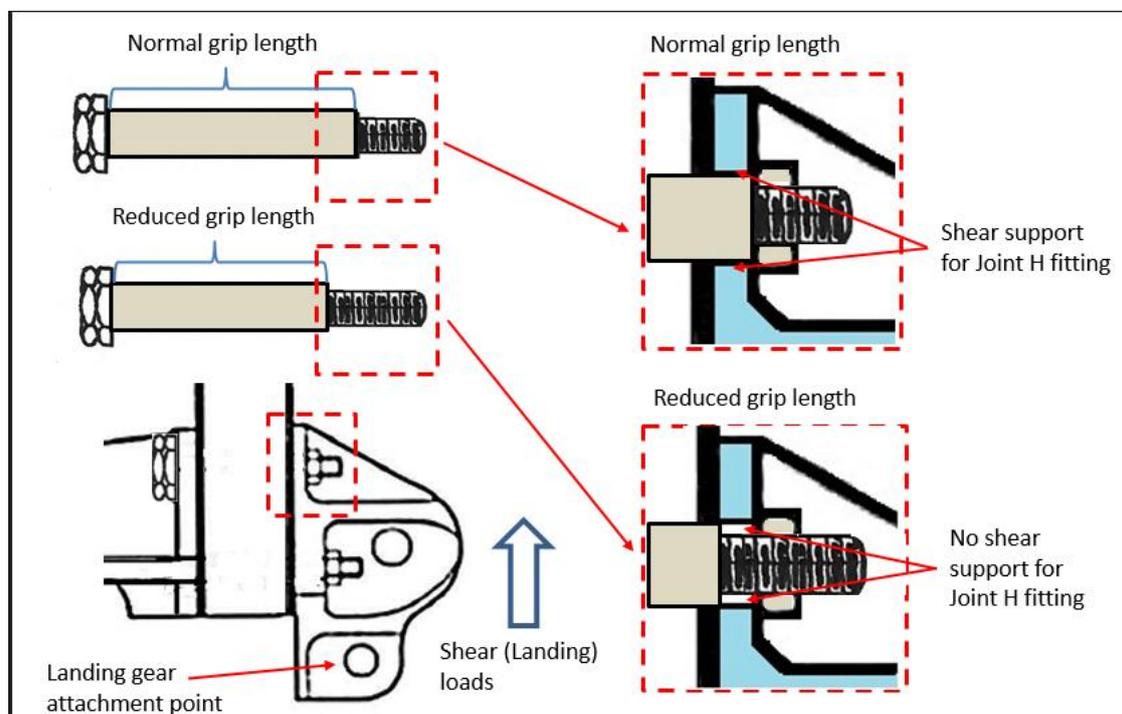
The H Joint upper attachment bolts are designed to work in conjunction with the lateral tie rods to transfer landing loads to the airframe. Unapproved, and typically short upper attachment bolts do not allow the shank of the bolt to properly engage with the fuselage structure and the Joint H fitting, and can allow the fitting to move up, and engage with the threads of the unapproved bolt, thereby subjecting the lateral tie rod to excessive shear loads, (Figure 3).

Figure 3. Correct and incorrect H Joint upper attachment bolt installation.
(Source: Adapted from ATSB Investigation AO-2013-226)
