AIRWORTHINESS BULLETIN

AWB 02-064 Issue 1 – 3 July 2020

Preventing Carbon Monoxide Poisoning in Piston Engine Aircraft

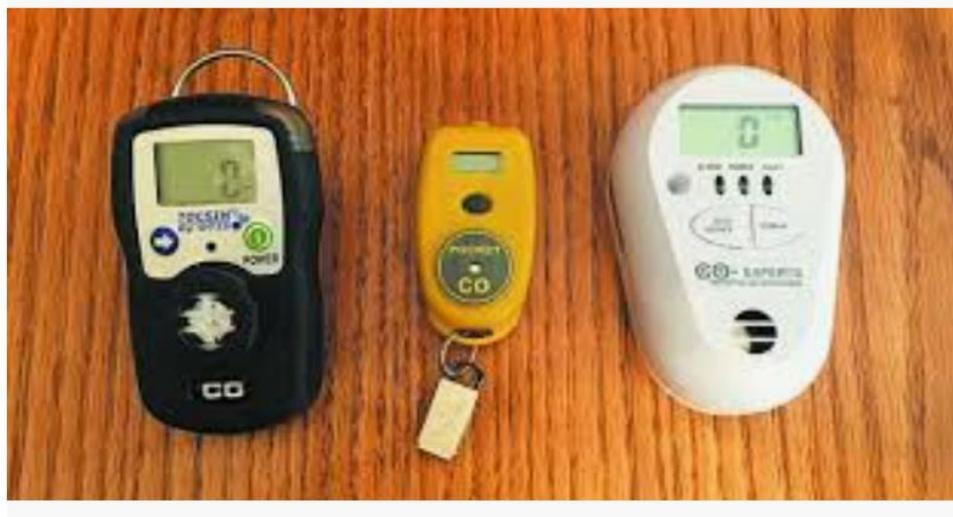
Figure 3

Electronic CO detector devices available for personal use.

Finally, whilst not all aircraft are required to have CO detectors fitted, small electronic personal devices are available at relatively affordable prices, these devices allow for continual monitoring of CO levels with audible and visual warnings when escalated CO levels are detected.

Aircraft certified and hard-wired products are also available that can be installed by approved maintenance repair organisations. Reliance on only the visual CO indicator placard, that changes colour in the presence of CO, is considered suboptimal.
