Airworthiness Bulletin

AWB 01-033 Issue 1 - 11 March 2021

DH82 Series Tiger Moth – Unapproved Joint H Structural Bolts

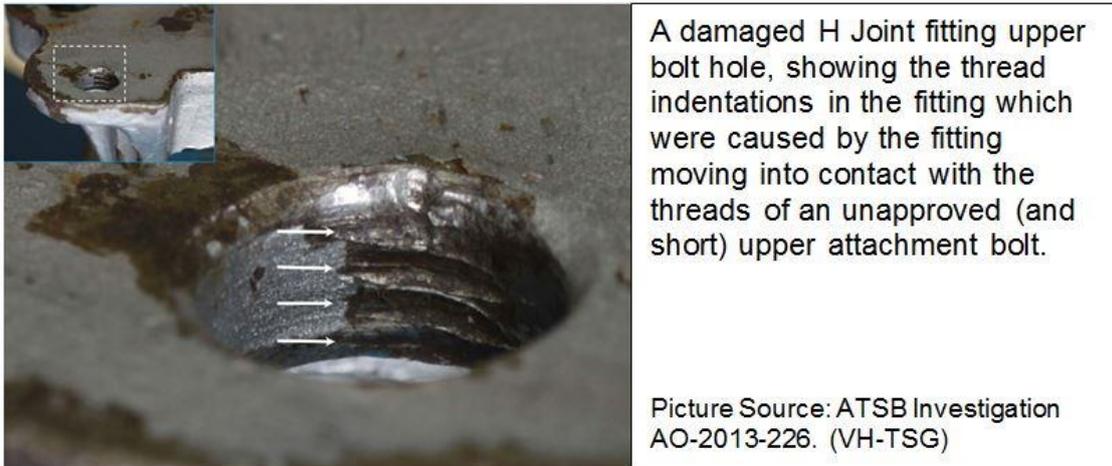
Figure 4.

The H Joint upper attachment bolts are designed to work in conjunction with the lateral tie rods to transfer landing loads to the airframe. Unapproved, and typically short upper attachment bolts do not allow the shank of the bolt to properly engage with the fuselage structure and the Joint H fitting, and can allow the fitting to move up, and engage with the threads of the unapproved bolt, thereby subjecting the lateral tie rod to excessive shear loads, (Figure 3).

Remove all unapproved bolts. Inspect the bolt holes and take action as required in accordance with the current issue of DHSL CT Moth TNS data, including inspecting the inside of the H Joint fitting for thread marks and for gouging in compression tube end fitting caused by unapproved oversize bolt head fouling. H Joint bolt removal and installation should be accomplished with the aircraft on trestles.
